DAMAGE TANK REPORT

TANK NO: ICSU028666 3

LAST CARGO: FURFURAL

SURVEY DATE: March 24, 2008

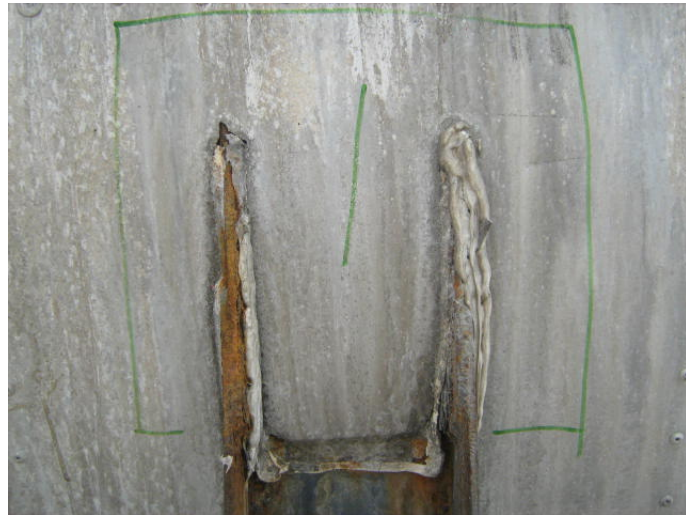
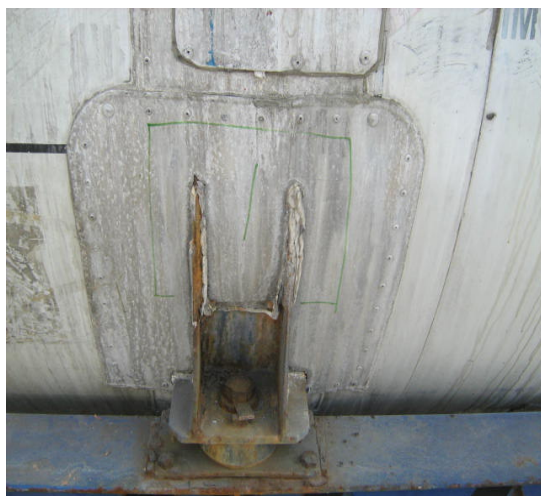
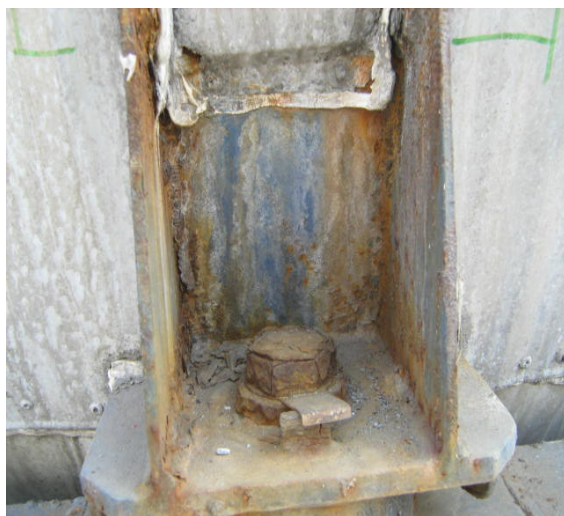
1,LOCATION 1#

Did not be found new

Damage evidence, The

loaction has been

repaired at unknow

place and unknow time. Much rust were found at the loaction.

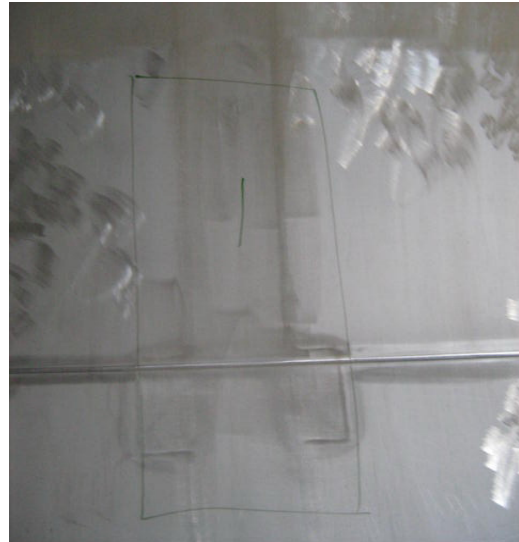
We are not found any damage or dent at the loacation 1#.

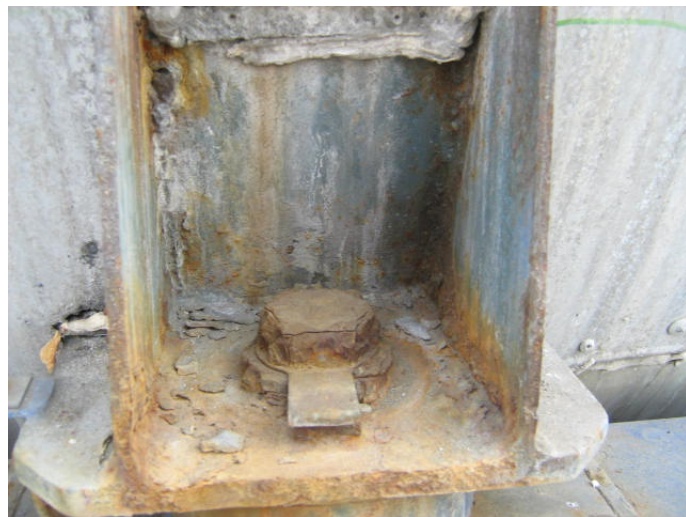
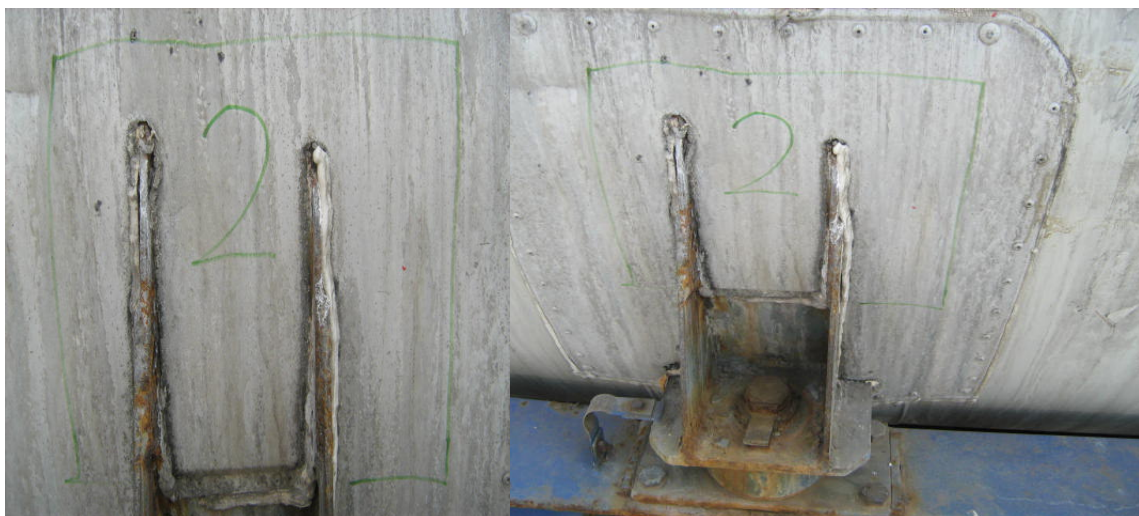
2, Loacation 2#

We are not find new Damage evidence, The loaction has been repaired at unknow place and unknow time. Much rust were found at the loacation.

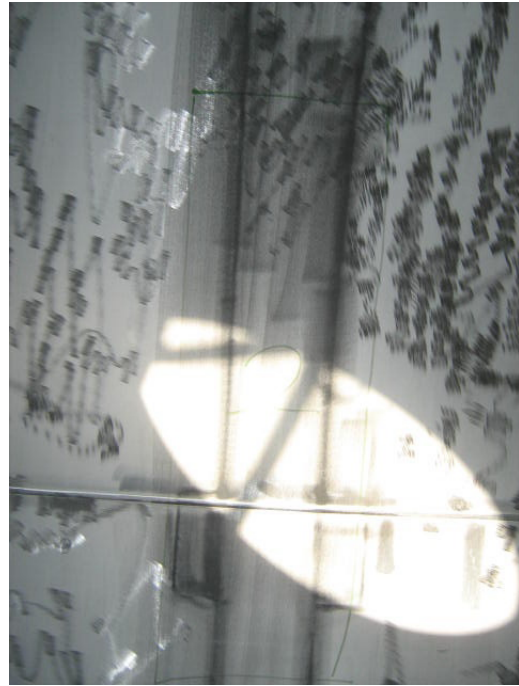
We are not found any damage or dent at the loaction 2#.

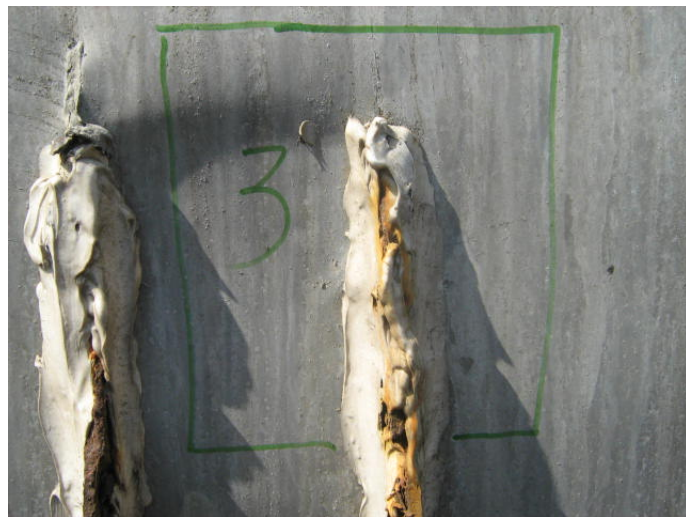
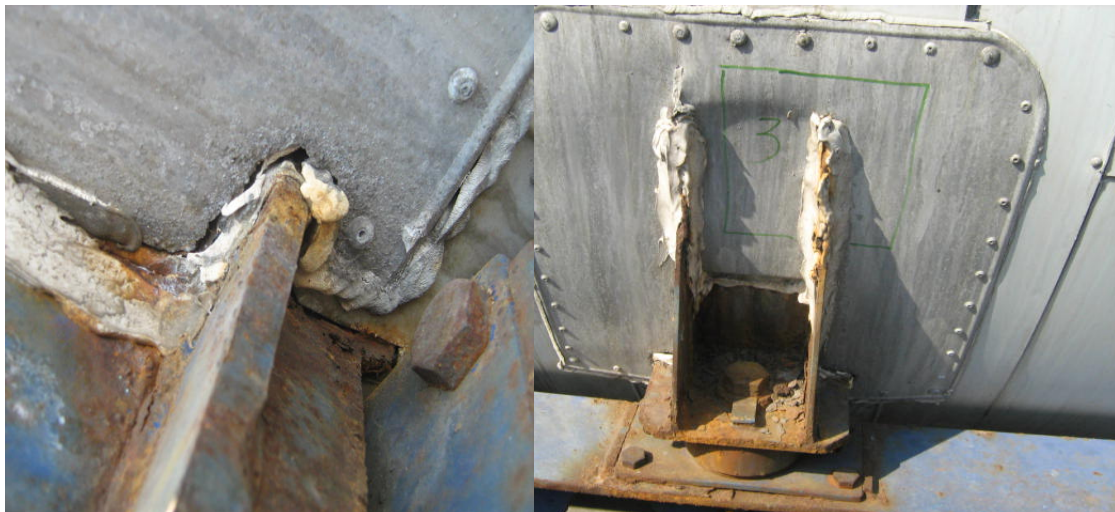
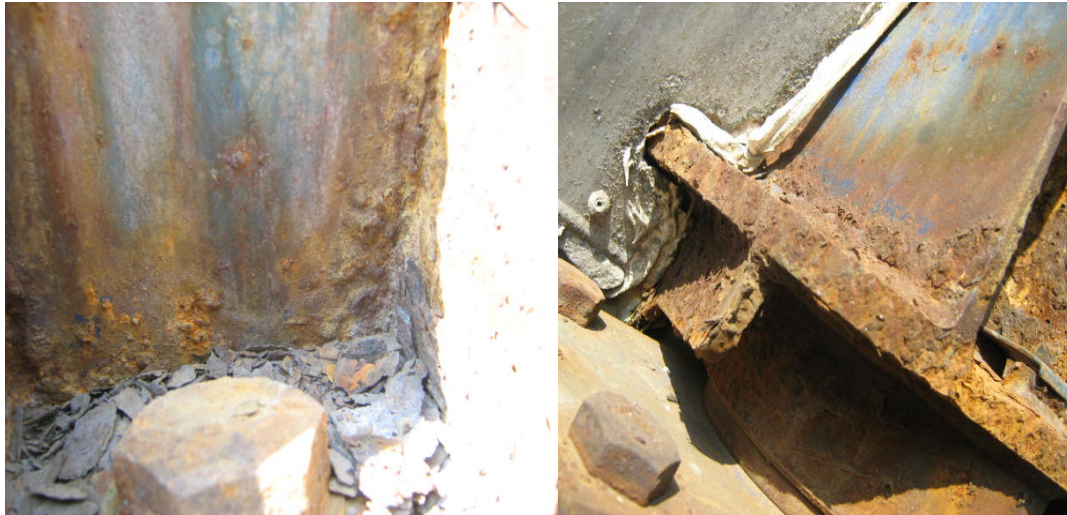
3, Loaction 3#

The loaction was found much rust and be repaired at unknow time and unknow place. But no found leakage evidence.

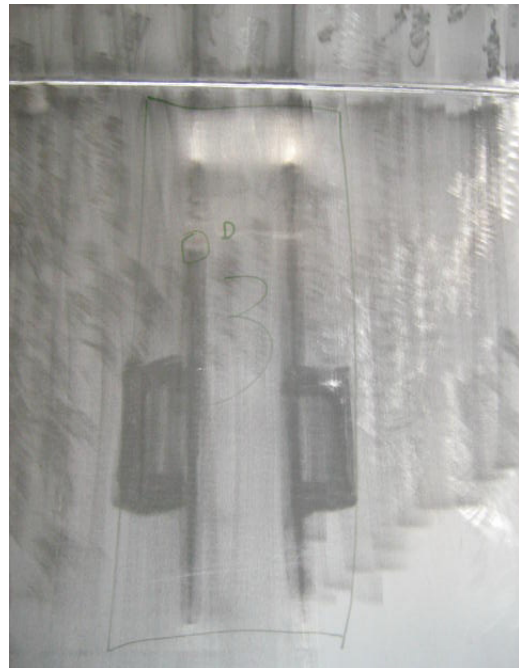
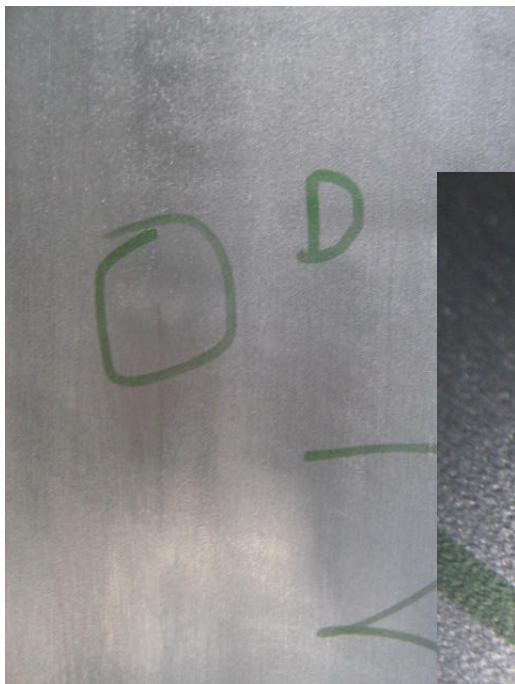
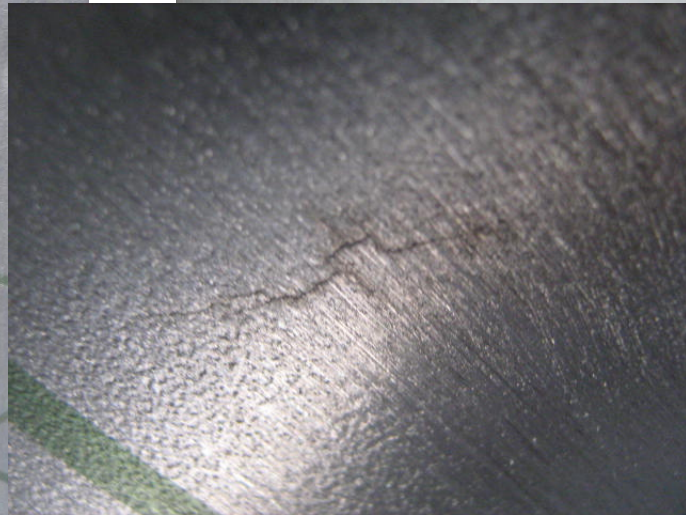
Crack was found at interior of the
loactaion 3# , the crack length
about 3 cm

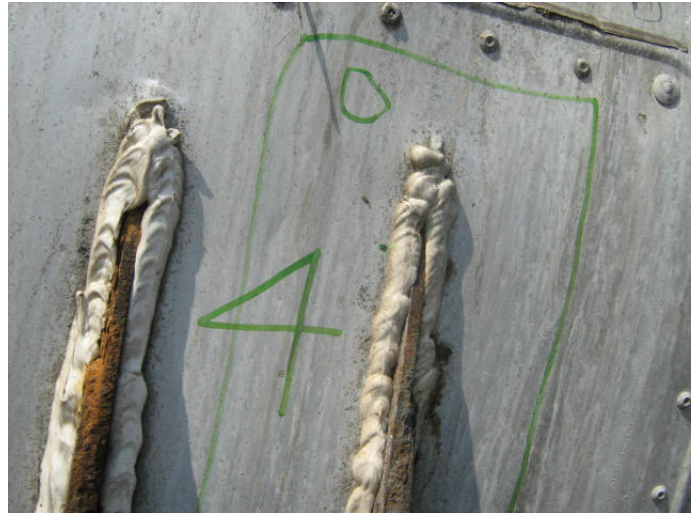
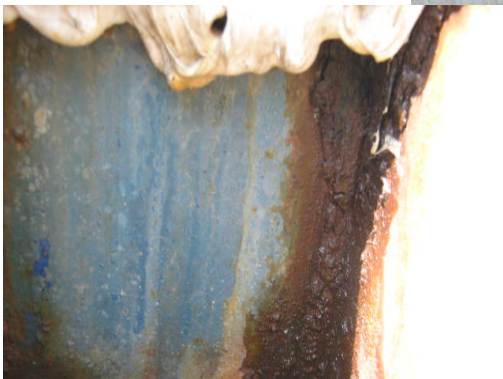
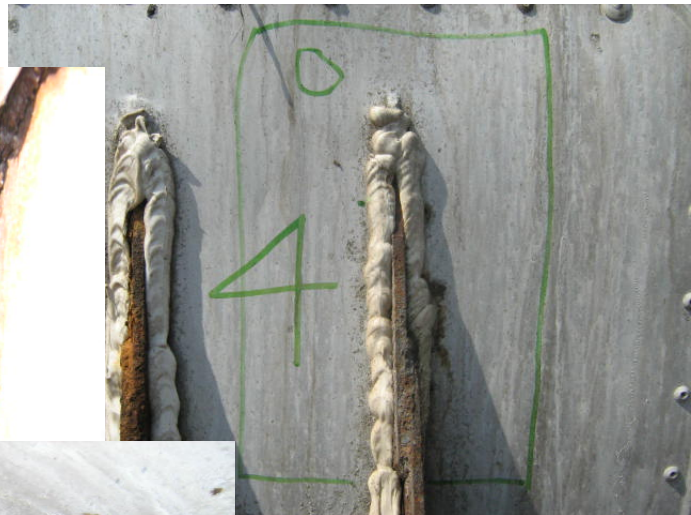
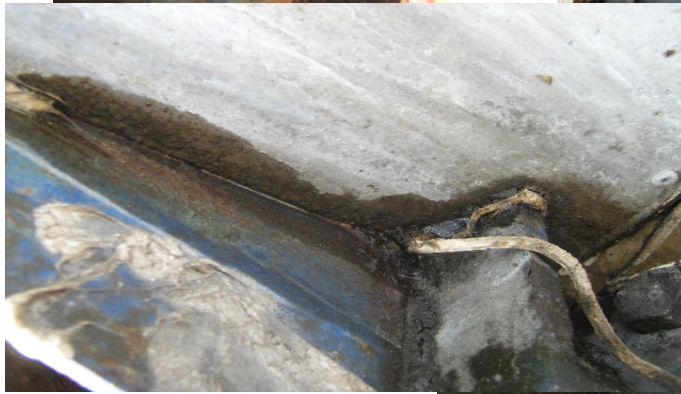
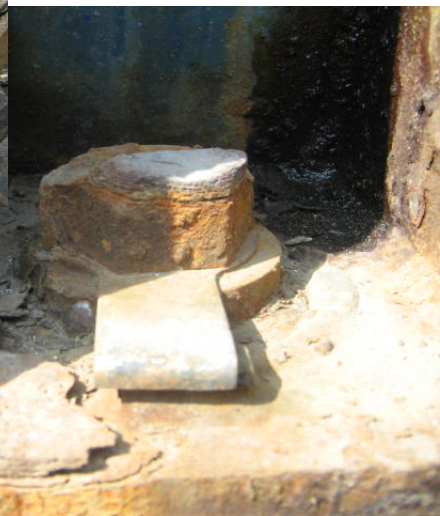
4, Location 4#

This is leakage location.

Be repaired at unknown
place and on unknown

time. Much rust and

cargo stain were found at the location 4#. But no found any new
damage evidence.

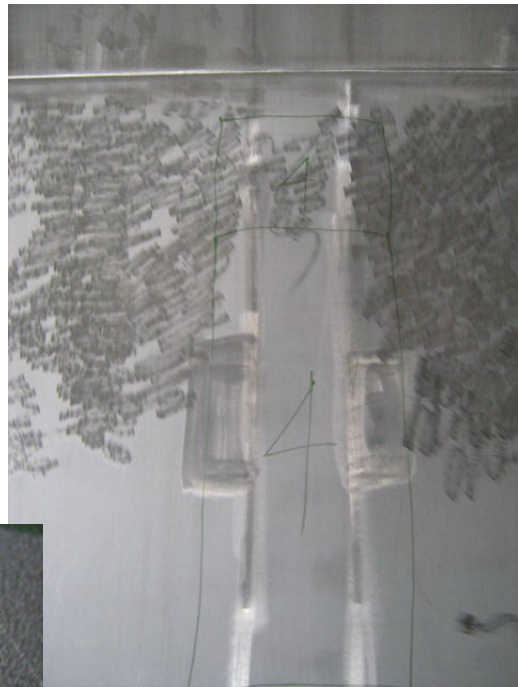
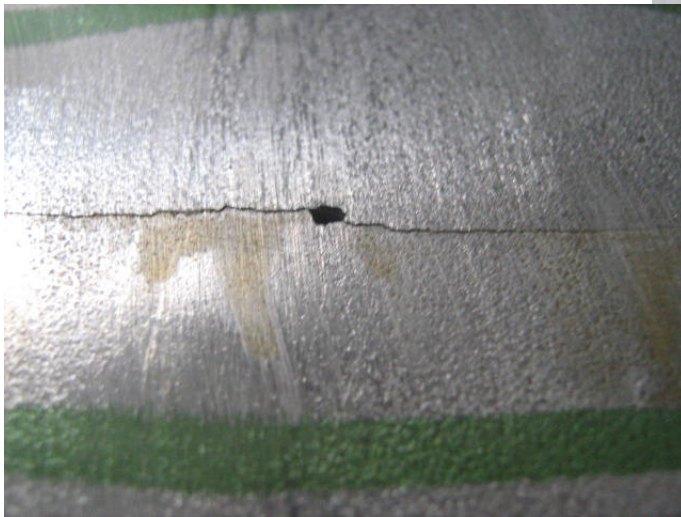
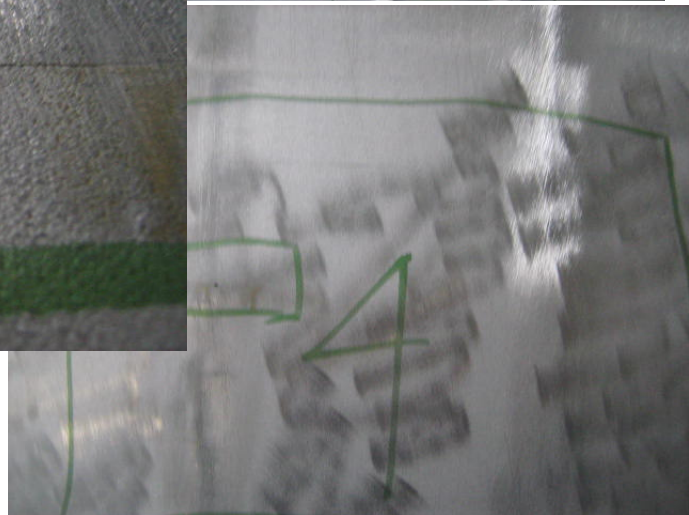
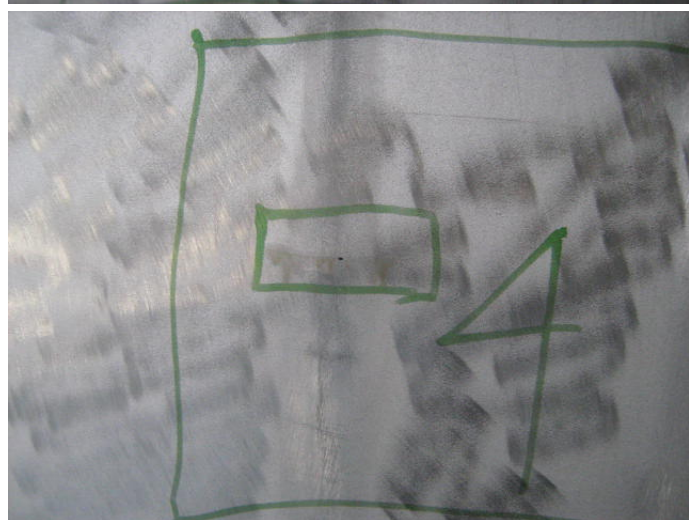
Crack, pitting and dent were found at the location 4#, The length is about 5cm, and the pitting length is about 5mm.
